PLANNING AND DESIGN

A Case Study: An Examination of Access for Those With Disabilities at Revenue-Generating Sport Facilities at an NCAA Institution

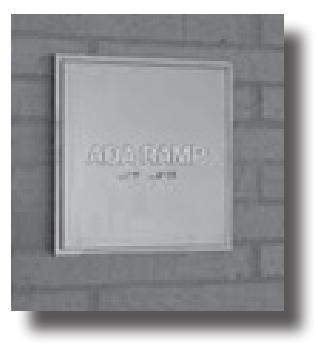
Ramps. The main physical barriers present at the stadium were ramps leading to the accessible seating area. The *ADA Standards for Accessible Design* (Department of Justice [DOJ], 2010) requires a maximum rise over run ratio of 1:8 (§405.2). These ramps were constructed at a steep 16.67° incline, or approximately 1:3 slope. In order to climb the ramp successfully in a wheelchair, the researcher assuming disability needed the help of another researcher. In line with ADA regulations, most ramps were correctly marked with an ADA ramp marker (Figure 1).

Figure 1. ADA ramp markers indicate accessible routes between levels.

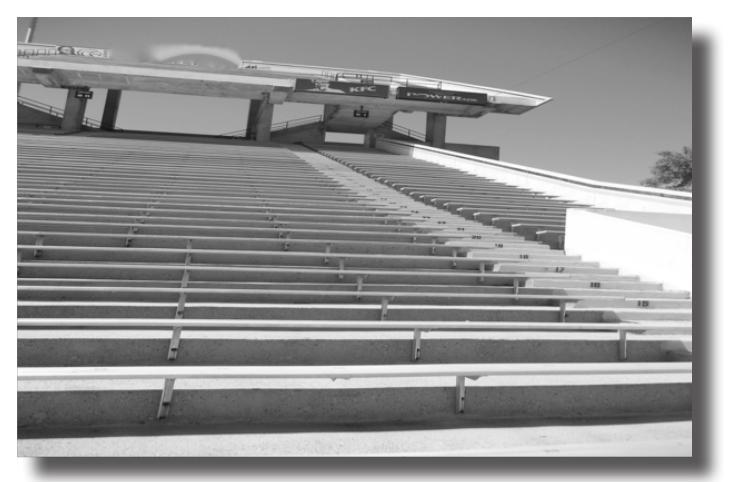
Stairs. The height of each stair in the stadium is 6 in. (Figure 2). This measurement falls within the ADA standards (DOJ, 2010), which allows a minimum of 4 in. and maximum of 7 in. for single stair elevation (§504.2). This will aid individuals who use assistive devices (e.g., crutches, walkers) for mobility or for those whose walking abilities are limited.

Figure 2. Stair height of bleachers is regulated to accommodate persons with mobility.

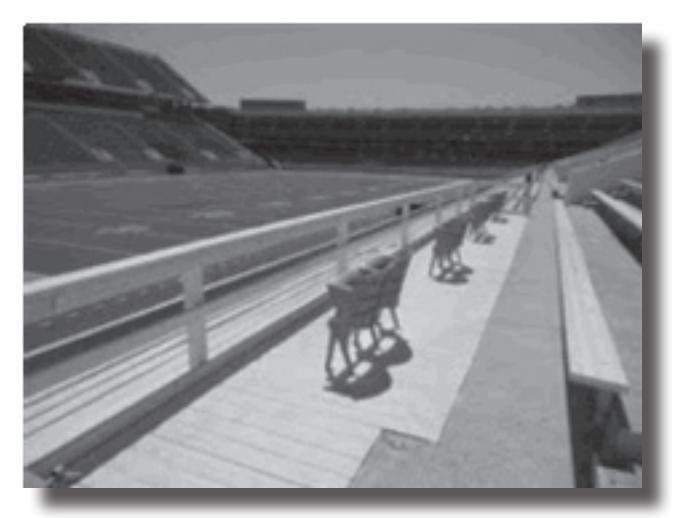
Seating. The maximum capacity of the stadium is 36,000 people. Roughly 40 seats were wheelchair accessible (Figure 3). In addition, this included companion seating, which means there could be as few as 20 wheelchair seats available. This number of seats is not adequate enough to meet current ADA guidelines (DOJ, 2010), which state that the total number of wheelchair accessible seating for any assembly area consisting of over 5,001 seats is 36 plus 1 for every 200 seats over 5,001 (§ 221.2.1). For a stadium of 36,000 seats, at least 191 would be required for wheelchair spaces. Future modifications of the stadium could include increasing the number of wheelchair accessible seating to reflect current ADA standards.

Figure 3. The number of wheelchair accessible seats falls short of current ADA guidelines.

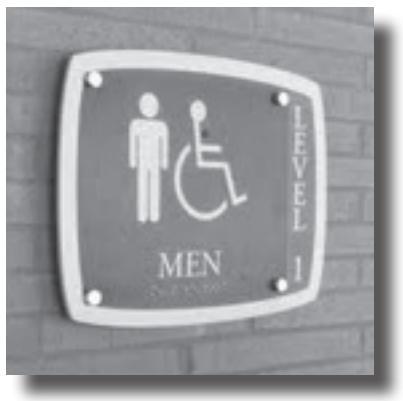
In the newer portion of the stadium, wheelchair accessible stalls were larger than those found in the older sections, in compliance with ADA regulations. The grab bar located on the rear wall above the toilet met ADA guidelines, which state that rear wall handrails should have a minimum length of 36 in. (Figure 4; DOJ, 2010; §604.5.2).

Figure 4. Bathrooms were properly marked with appropriate signage.

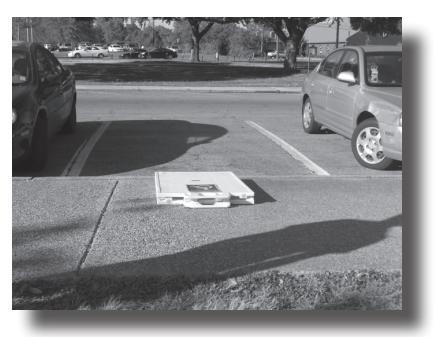
However, all of these slots are standard-sized car spaces converted to pseudo-accessible parking by placing large symbols of access at the head of each space (Figures 6 and 7). The proximity of the cars placed adjacent to each other hinders easy exiting of the vehicle for those with wheelchairs or assistive devices, which typically require doors to be open wide to accommodate the equipment. Possible upgrades for the parking lot include repaying the concrete, creating permanent and wider car slots for the disabled, and also constructing a sidewalk accessible to users of wheelchairs.

Figure 6. Some parking spots are reserved exclusively for those with disabilities on a temporary basis.

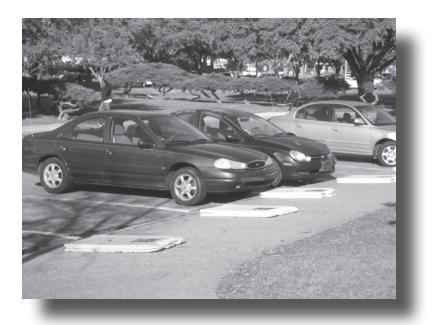
Figure 7. Pseudo-accessible parking does not accommodate those needing extrawide spaces for wheelchair exit from the vehicle.

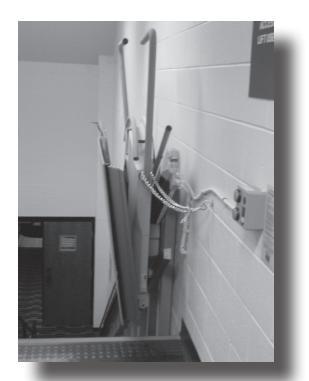
Lifts. Lifts are needed in sporting event facilities to assist individuals unable to ascend stairs without assistance. The arena includes a lift that can carry a maximum weight of 465 pounds (Figure 8; personal communication, April 11, 2011). With this capacity, the lift can accommodate most patrons in need of its use.

Figure 8. Lifts assist those who are unable to ascend stairways.

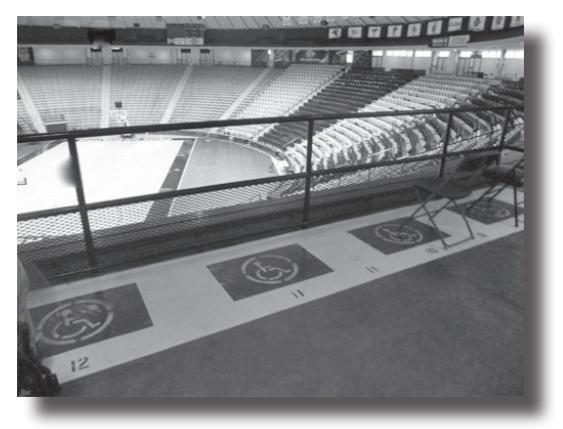
Seating. Out of the 8,095 possible seats in the arena, only 17 are accessible to persons with disabilities (Figure 9; personal communication, April 11, 2011). This number falls staggeringly short of the ADA guidelines (DOJ, 2010), which recommends 52 seats for a sporting facility with this seating capacity (§ 221.2). Prices for these seats are the same as standard seats, which is encouraging to those who would benefit from this offer. Additionally, users of wheelchairs can buy floor seating, but the only available restrooms are located on the upper levels of the arena. Suggested improvements include installing an elevator for people using a wheelchair to have easier access to the upper levels or placing accessible stalls in bathrooms on the lower floor, as well as increasing the number of accessible seats to reflect current ADA standards.

Figure 9. With over 8,000 arena seats, only 17 designated spots are accessible to persons with disabilities.

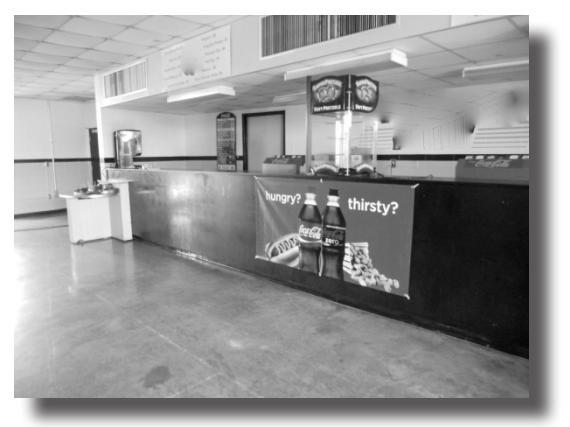
Concessions. Concessions are a relevant part of any sporting event. People with and without disabilities enjoy being able to access these with ease. Concessions stand countertops in the arena were 52 in. high, which makes visibility and transfer of goods to users of wheelchairs difficult (Figure 10). To facilitate employee–client visibility and transactions at the concessions stand, at least one or more portions of the counter space should be lowered to 34 in.

Figure 10. Countertop height at concession stands prevents clear visibility and transfer of goods to wheelchair users.

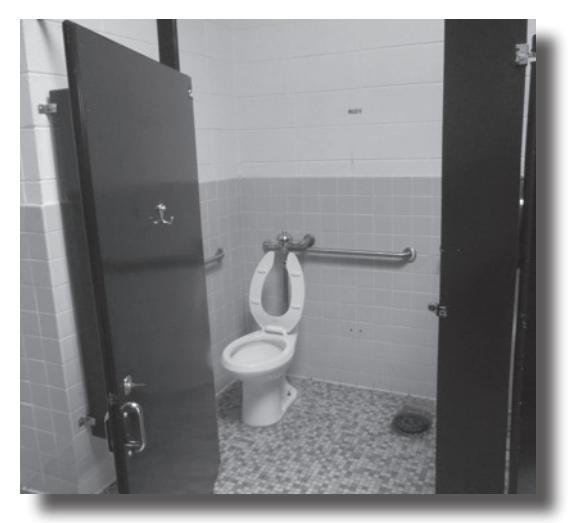
Bathrooms. Of the 24 total stalls inside the arena, only two are designated as accessible, one per gender (Figure 11). These are located only at the upper section of the arena, not the floor level. The amount of space within the stall is large enough to accommodate the user of a wheel-chair comfortably. We suggest the inclusion of one wheelchair accessible stall per bathroom to increase accessibility.

Figure 11. Accessible bathrooms accommodate wheelchair width and include grab bars.

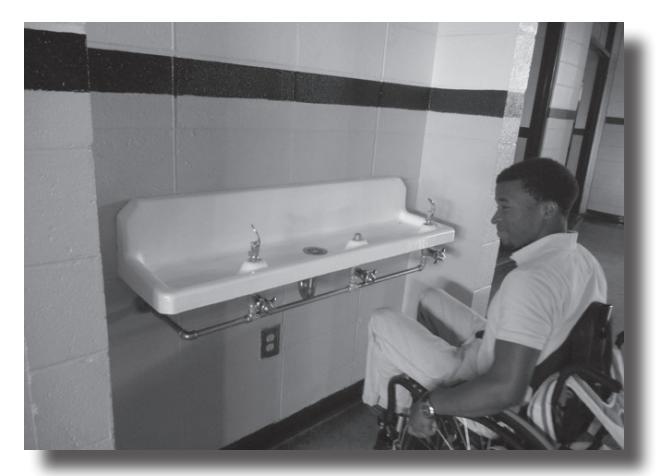
Drinking fountains. Drinking fountains located near bathrooms were 36 in. from the ground, in line with ADA standards (DOJ, 2010; §602.4). This height is accessible to patrons using wheelchairs or those of short stature (Figure 12).

Figure 12. Accessible drinking fountains stand 36 in. from the ground.
